EVALUATION OF SERVICE LUBRICANTS AND METALS.(U)

EVALUATION OF SERVICE LUBRICANTS AND METALS

Final Technical Report

T Nonaka and A Cameron

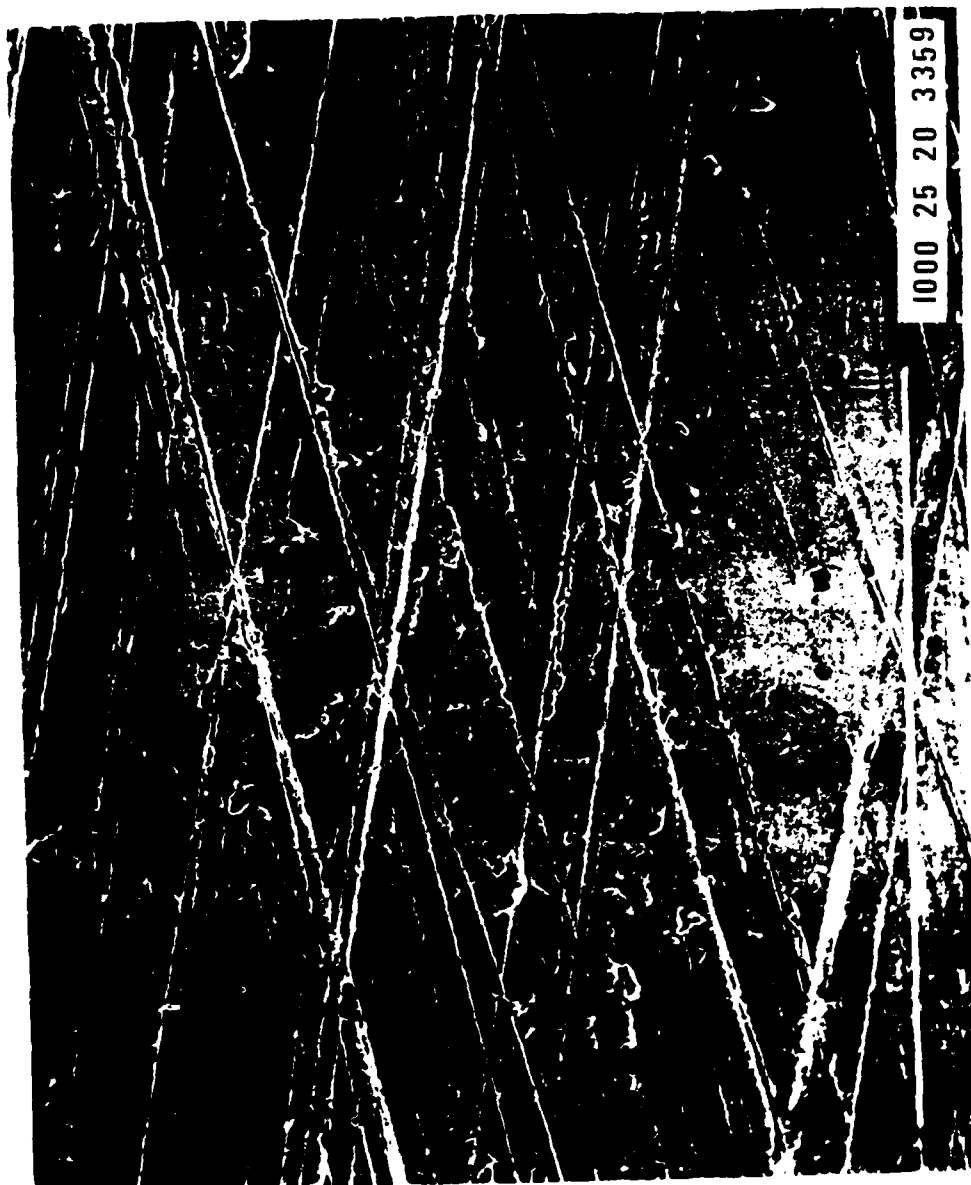
Photograph 3

Wear scar on AL-6855-L oil test. The wear is slight and there are few evidences of scuffing. This means that a chemical film has prevented metal-metal contact. This is expected from the high electrical contact resistance and the low friction force shown in the recorder traces.
